The Road Inventory of Jones Hole National Fish Hatchery Vernal, UT

Prepared By:
Federal Highway Administration
Central Federal Lands Highway Division
April 2008

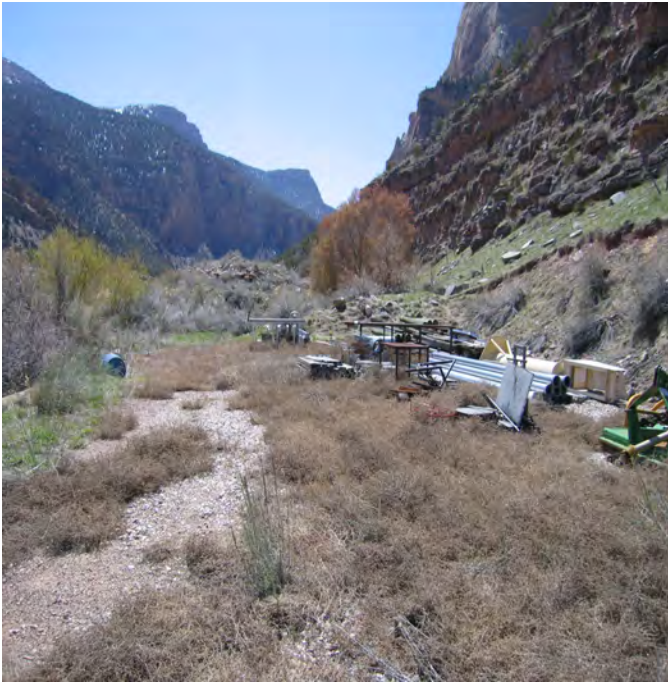
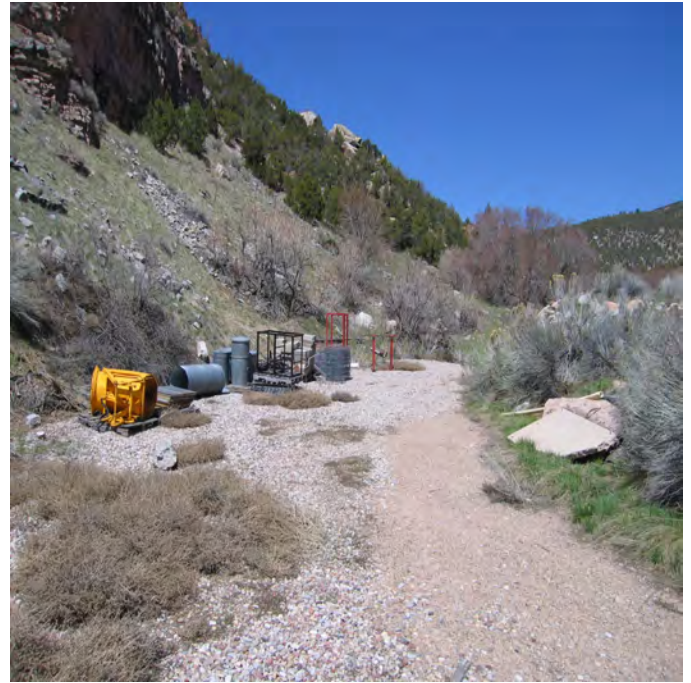
Route 800: Boneyard Parking and Storage

Asset Number	Date Visited	Surface Type	Area (sq ft)	Condition	Cost to Improve
10049846	4/27/2008	Gravel	5910	Poor	\$6124

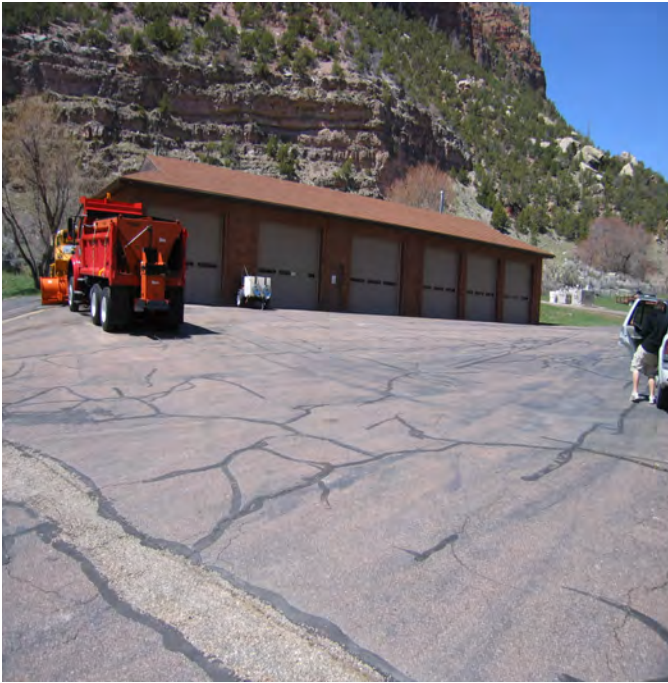
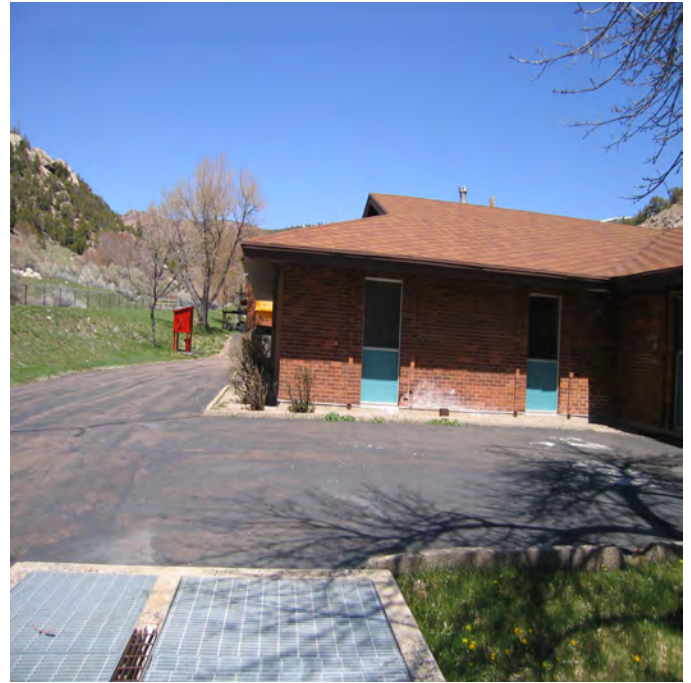
Route 801: Administrative Asphalt Parking

Asset Number	Date Visited	Surface Type	Area (sq ft)	Condition	Cost to Improve
10033081	4/27/2008	Asphalt	12530	Good	\$2181

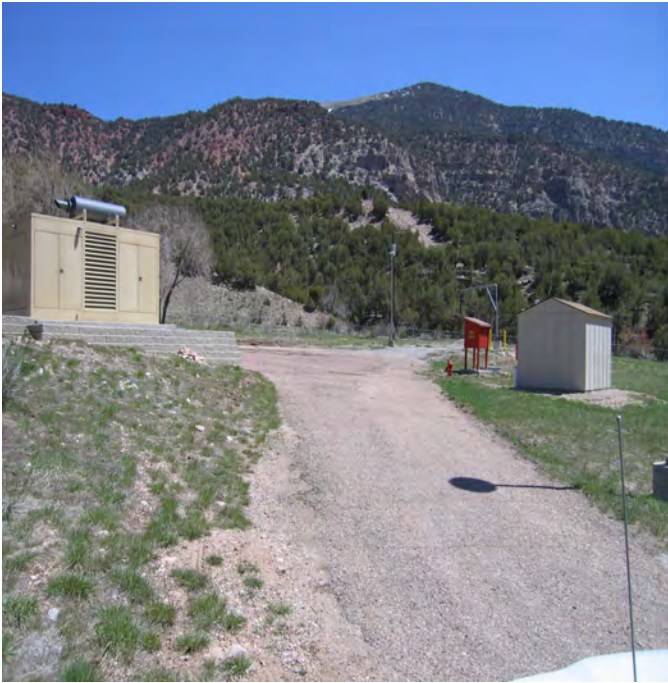
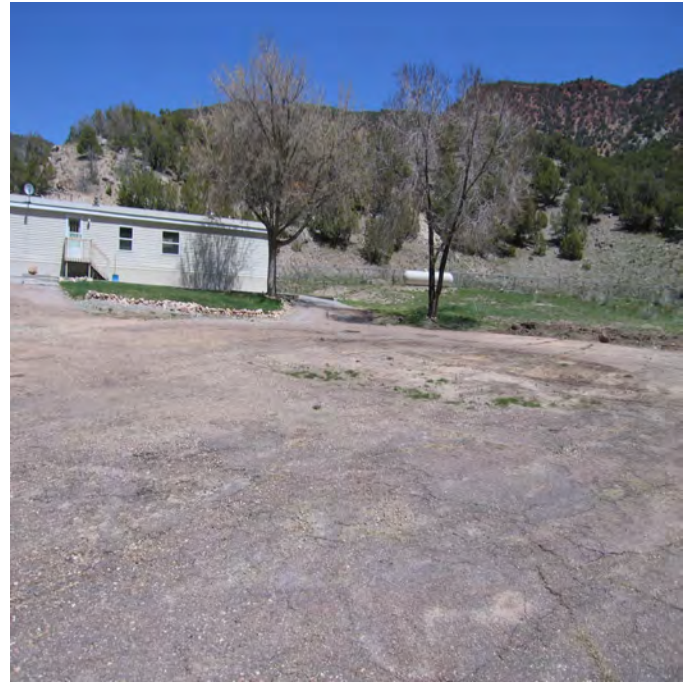
Route 802: Administrative Parking North

Asset Number	Date Visited	Surface Type	Area (sq ft)	Condition	Cost to Improve
10033081	4/27/2008	Asphalt	7150	Poor	\$32186

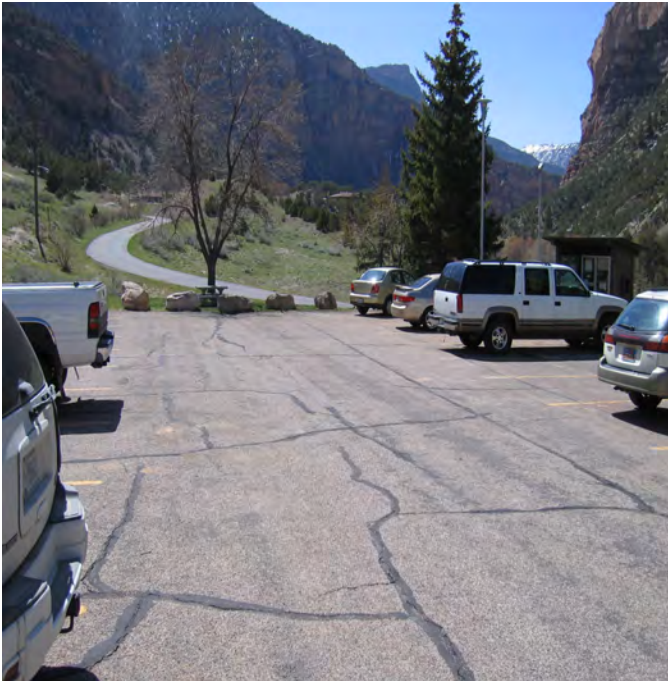
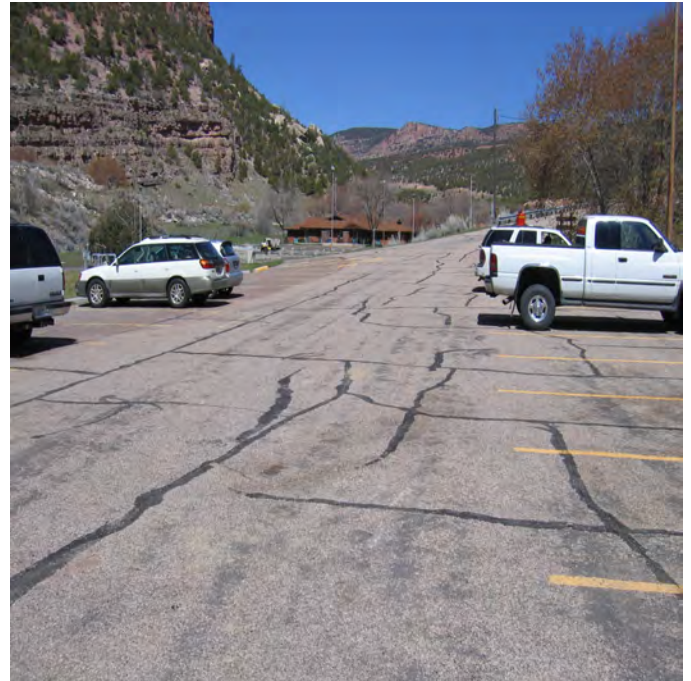
Route 900: Visitor Parking

Asset Number	Date Visited	Surface Type	Area (sq ft)	Condition	Cost to Improve
10049840	4/27/2008	Asphalt	7931	Fair	\$6378

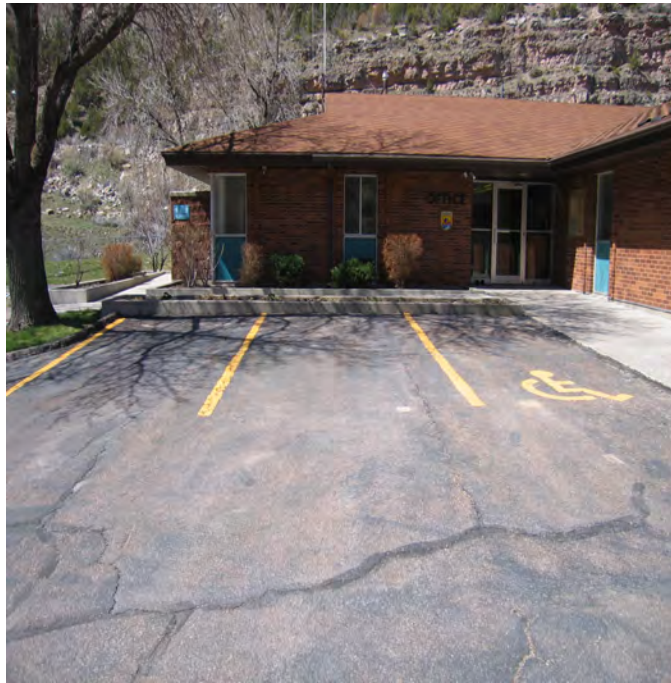
Route 901: Handicapped / Office Parking

Asset Number	Date Visited	Surface Type	Area (sq ft)	Condition	Cost to Improve
10049841	4/27/2008	Asphalt	624	Fair	\$502
